MICROSLEEVE

**CATALOG
2003-IV**

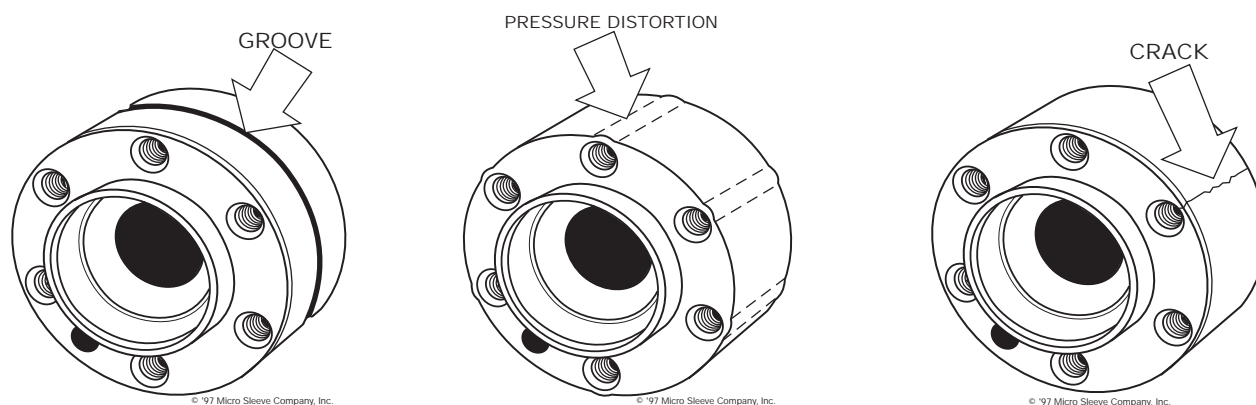
During the normal course of use, the seal will wear a groove in the crankshaft flange.

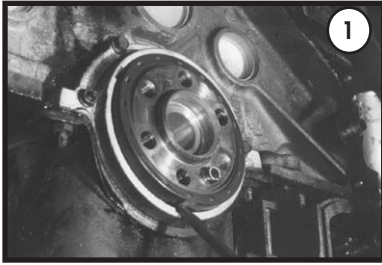
1
Removal of leaking rear main seal on a 5.7L Chevrolet Suburban.

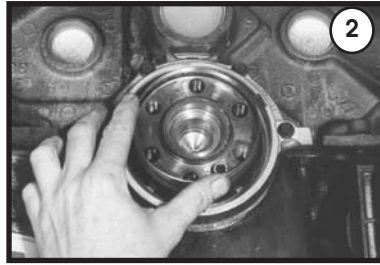
2
Wipe crankshaft flange clean and position Micro Sleeve crankshaft seal surface sleeve.

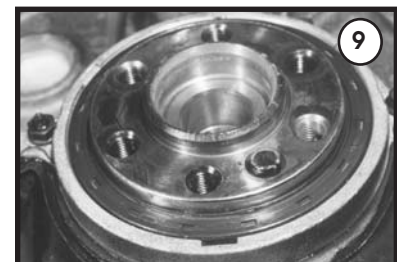
9
New seal surface - new seal - no leaks courtesy of Micro Sleeve "In-Vehicle" full circle rear main seal repair.
